Article

Applied Research of the Hygrothermal Behaviour of an Internally Insulated Historic Wall without Vapour Barrier: In Situ Measurements and Dynamic Simulations

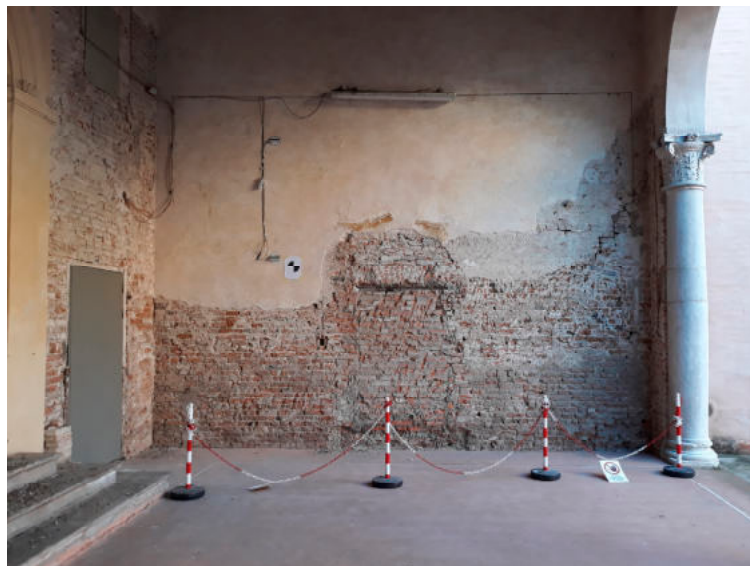
Figure 3. External view of the studied wall (internal courtyard under the porch) [6].

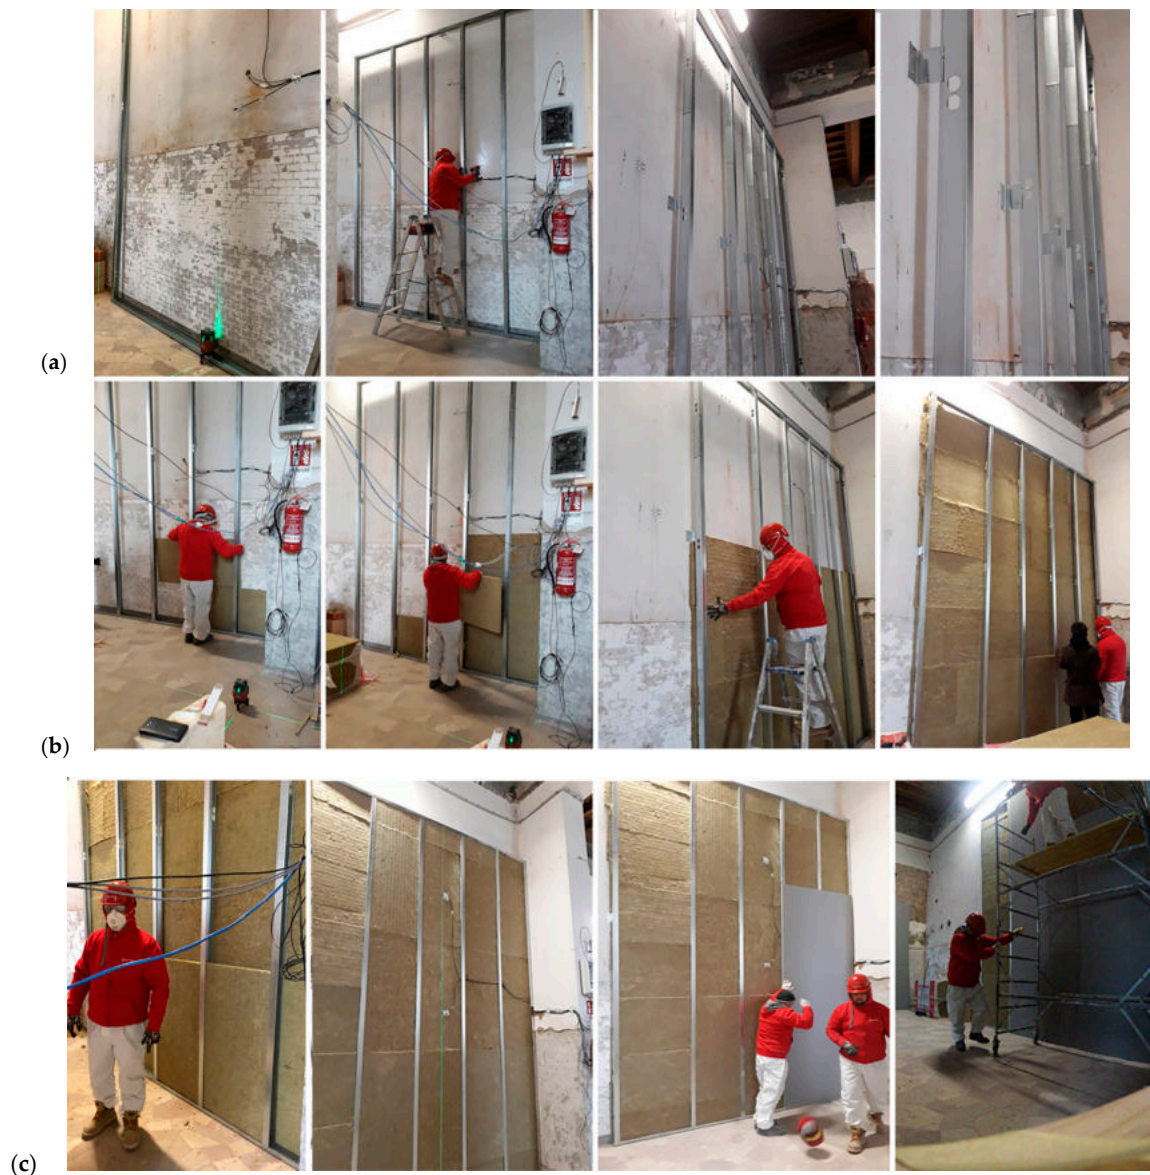
Figure 4 shows the phase's sequence of the installation of the selected insulation system: in (a), the installation of the C metal structure outdistanced from the wall to minimize the number of anchor points on the historic wall; in (b), the insertion of the additional insulation layer between the metal frame and the wall; finally, in (c), the interposition of the second stone wool set of panels between the vertical steel elements, then covered by the gypsum board finishing.

Figure 4. Installation of the selected insulation system.

Finally, the insulation stratigraphy selected by the technical worktable is composed by a first insulation panel 40 mm thick, a second insulation layer 60 mm thick, interposed between the metal frame, and the gypsum board finishing (12.5 mm).

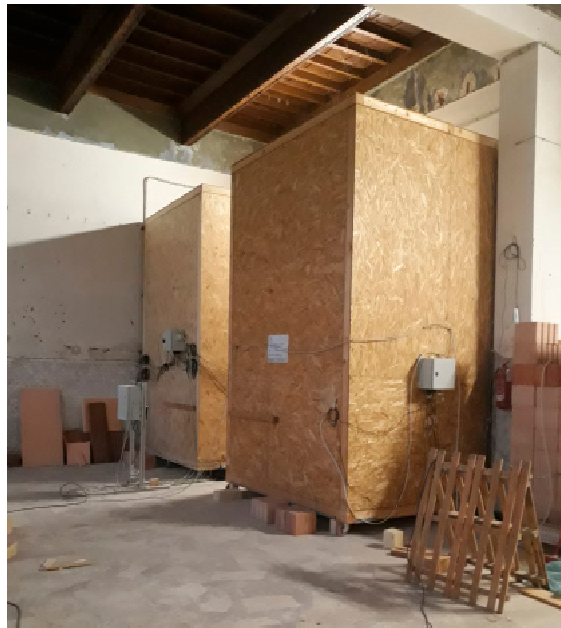
As pointed out earlier, inside the 700 m³ room, two smaller volumes (25 m³/each) were constructed. In each volume (Figure 5), a standard indoor environment was set-up [indoor air temperature (T_a) \approx 20 °C and relative humidity (RH) \approx 55%], according to the main international guidelines as EN ISO 7730 [42], EN ISO 13788 [43] or ISO 17772-1 [44]. Besides its special features (0.10 m high density stone wool insulation material, lined with a vapour barrier on the inside), each box was provided of a 2000 W heating convector (with 3 power levels), regulated by control system; two ultrasonic humidifiers (argo HYDRO digit, Argoclima S.p.A., Alfianello, Italy), 30 W each, self-regulated, which permitted controlling the indoor comfort parameters, Figure 6.

Figure 5. Internal view of the room, with the two boxes tied up to the studied wall.

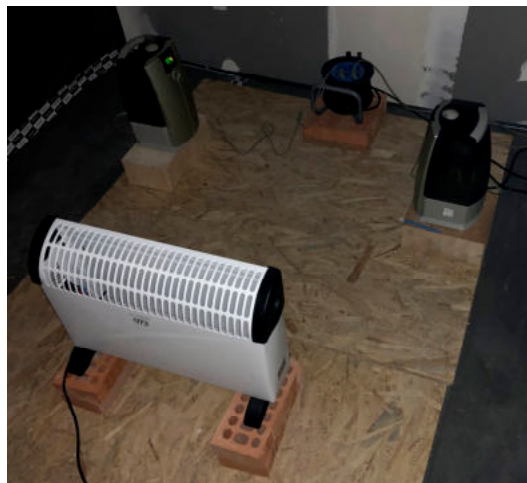
Figure 6. Hygrothermal control devices.

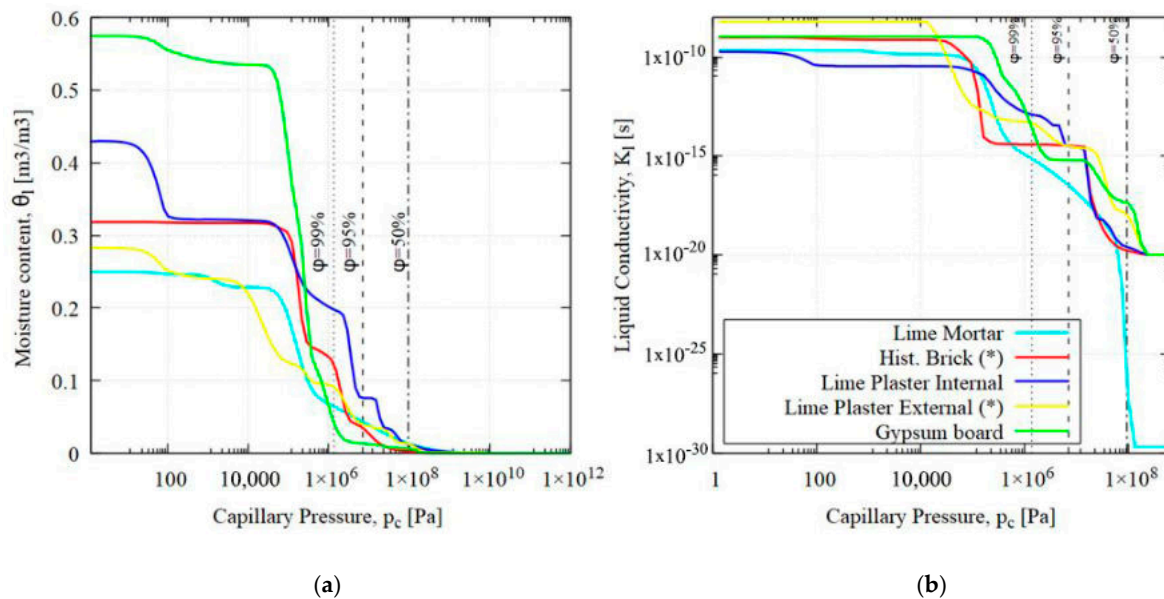
All the hygrothermal data regarding building materials are taken from Delphin's Material Database 6.0.20 [48] and were determined experimentally at the Climatology Laboratory at the University of Dresden. The building materials were selected from a specific historical cluster. In particular, brick and exterior plaster data refer to historic materials coming from a case study in Bologna and measured within the 3enCult European Project [14]. The hygrothermal characterization of the used stone wool, instead, comes from the material installed by the company involved in the HeLLo project. The characterization of the mentioned material for the dynamic calculation was performed in the laboratories of the Fraunhofer IBP (Institut of Building Physics) [49]; for this reason, data were appropriately formatted to fit the material characterization of the Delphin® database [48]. The main hygrothermal properties for all the used materials are presented in Table 2 and Figure 10. On the top of Table 2 (*), the materials that were characterized in the framework of the 3enCult Project are presented [14], while in Figure 10, the moisture storage function of the materials is shown: in (a), the moisture content is shown— θ_1 (pc); in (b), the liquid water conductivity as a function of the capillary pressure K_l (pc) is shown. In both, (a) and (b), the three vertical lines refer to the RH values of 50%, 95% and 99%.

**Figure 10.** Moisture storage function of the materials used for the 2D simulation.

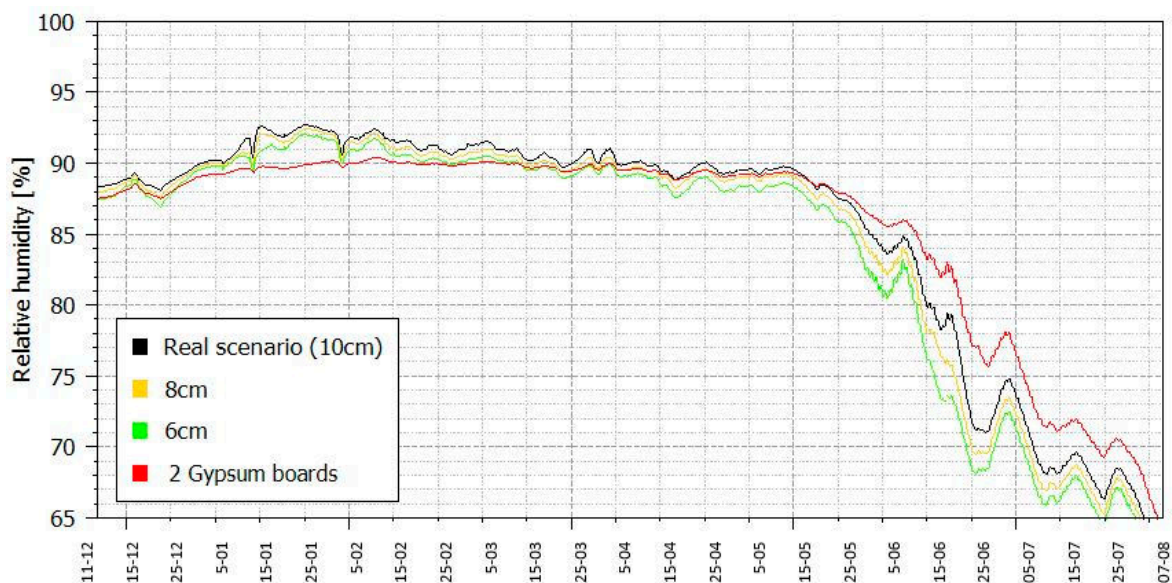
Figure 17 shows RH behind the insulation during the monitored period (11 December–11 March), plus the drying period (12 March–7 August) for the investigated wall. Moreover, scenarios with 6–8 cm of stone wool and 10 cm with two gypsum boards as the internal finishing layer are also presented, in order to compare the impact of different interventions. All the scenarios confirmed the initial simulation results: a strong decrease of RH from the wet to dry period of the year, emphasizing a significant reduction of moisture content in the summer.

Figure 17. RH in point C (Figure 9) during the period 11 December–7 August, for the simulated wall. Design scenarios of 6–8 cm of stone wool and 2 gypsum boards as interior finishing are included.

Contrariwise, in the third scenario, it resulted that improving the vapour resistance of the internal finishing with the use of the two gypsum boards, instead of one, may contribute to reduce moisture accumulation during the wetting period more efficiently than reducing the insulation thickness (Figure 17, first period).

Anyway, it is important to mention that, while the third scenario avoids reducing insulation thickness with consequent minor thermal losses, on the other hand, this design choice is responsible for a delay during the drying phase (Figure 17, second period). However, during the drying phase, moisture content significantly dries out from the interstitial area in all the studied cases. This phenomenon was also already visible in Figures 13 and 14 for the base case scenario.
